Mugonero and Muramba, Rwanda: June 2006

Addressing Public Health Challenges Through Education, Appropriate Water Collection and Treatment, and Biogas Generation Projects

Prepared by:
ENGINEERS WITHOUT BORDERS-USA
www-ewb-usa.org

Prepared: December, 2006

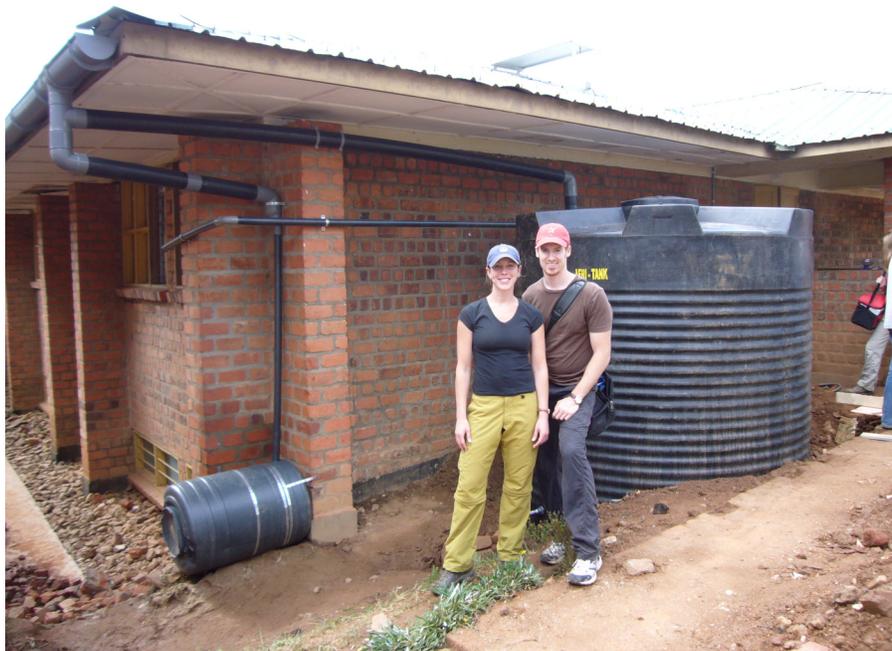
Final RWC Assembly

The foul flush tank has a small drain hole to slowly empty the tank after a rainfall in order to be re-used as a filtration system during the next rain shower. The foul flush tank is anchored on its side allowing the top lid to be opened for maintenance (debris removal).

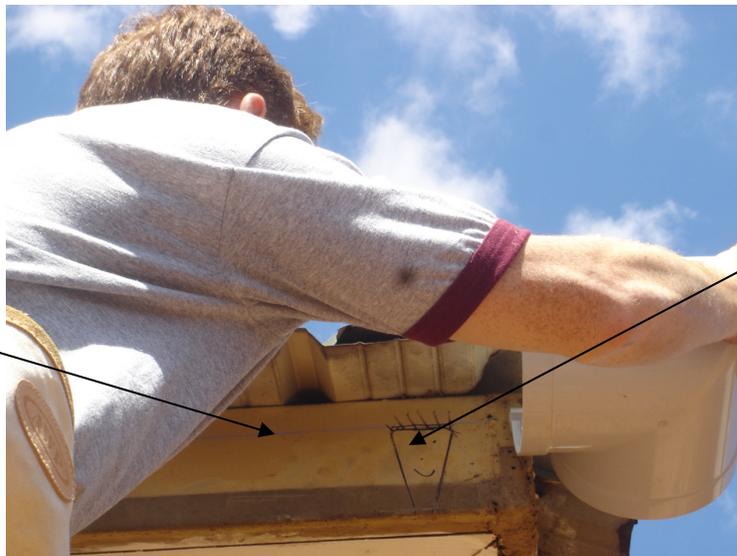
Drawn pattern of bracket

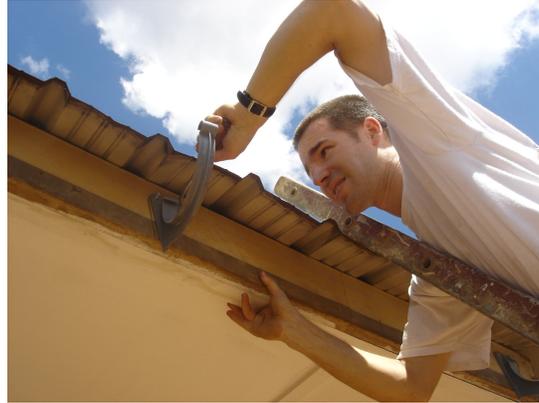
Fascia Bracket Installation

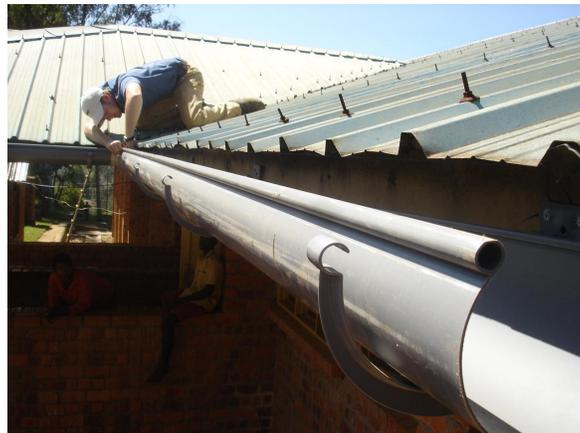
Figure 8: Gutter Installation

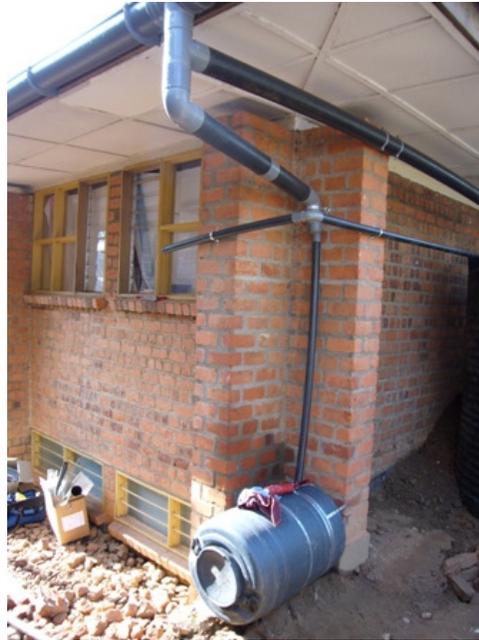
As water is collected from the roof and flows to the gutter downspout, the collected rainwater enters the filtration section of the system, commonly known as the “foul flush”. During periods without rainfall, dust, debris, and animal waste may accumulate on the roof. The concept of the foul flush is to let the force of the rainfall hitting the roof clean the surface before collection begins. This initial rainfall is diverted to the foul flush tank. Sediment and debris settles to the bottom of the foul flush tank, and once it fills the clean water is naturally diverted to the main collection tank. The clean water is separated from the dirty sediment by approximately 10 ft column of water. A small hole drilled in the base of the foul flush tank allows the water to slowly drain out over time.

Foul Flush

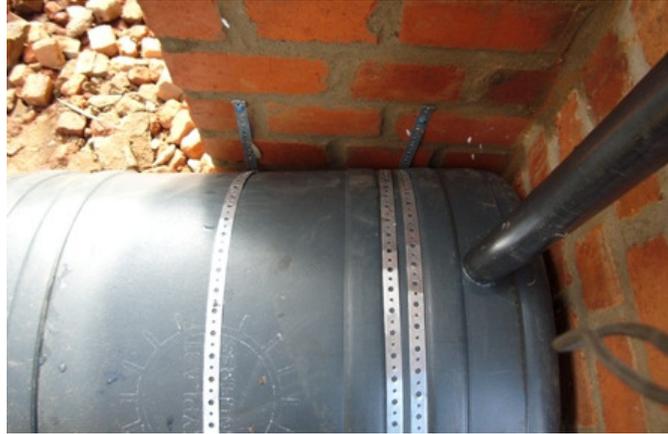
To facilitate ease of maintenance, the foul flush tank was set on its side. This allows maintenance personnel to open the lid, reach in, and remove debris. However, this configuration did prove troublesome in terms of securing the tank. The solution was to use metal pipe straps to anchor the tank into the building masonry.

Securing Foul Flush

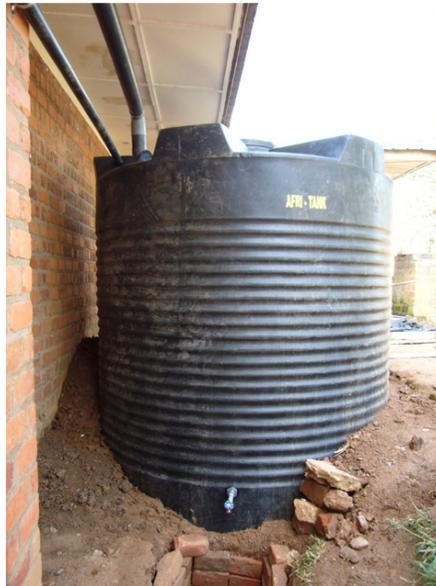
The collection tank was made from polyethylene and capable of holding 10,000 L (manufactured by Afri-Tank, 2.44 m diameter x 2.50 m height). Given the height of the roof where the tank was to be installed, a significant amount of earth needed to be excavated to provide adequate clearance for the tank, and the ground leveled to provide a stable resting surface.

Main collection tank

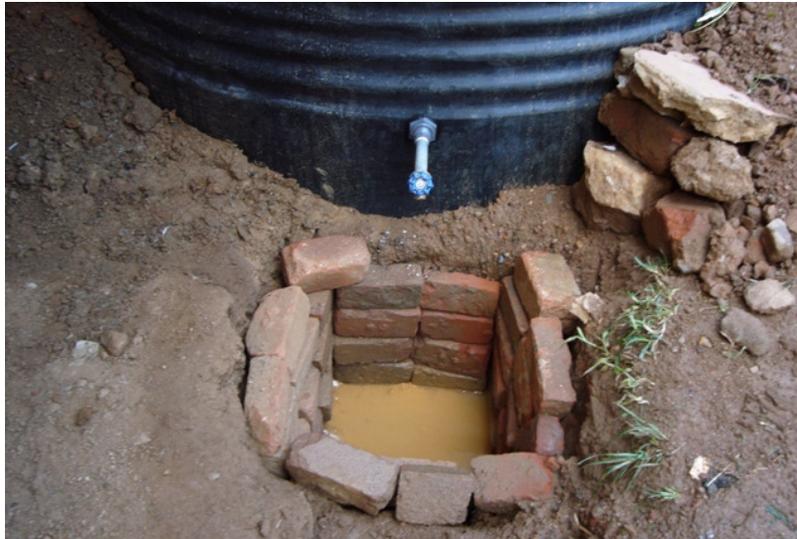
The tank spigot was installed 1 ft above the tank base to allow a bucket or jerry can to fit underneath. This ensured water would be extracted from the tank at the optimum location (any remaining sediment would settle to the bottom of the tank). A pit was dug at the spigot and lined with bricks. The hospital maintenance staff was to complete the masonry work at a later date.

Figure 16: Tank Spigot

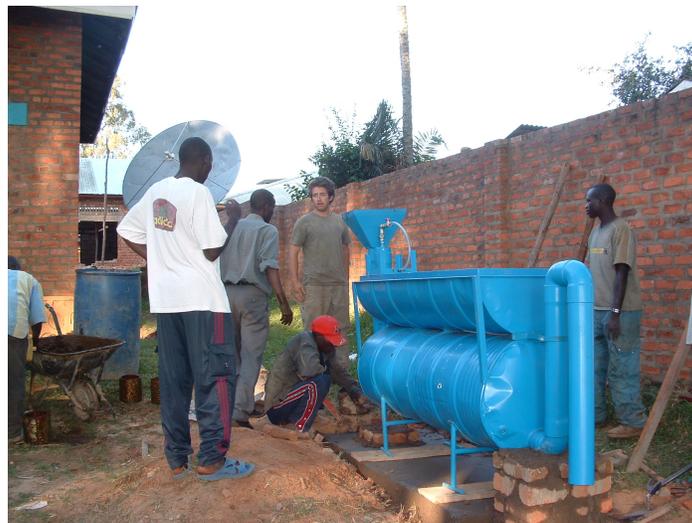
The 600 liter demonstration size reactor is designed to provide 200-600 litres of biogas per day, approximately enough to boil 10 liters of water. The reactors built by KIST consist of two 55 gallon drums, PVC and metal pipes, and fitted sheet metal, and some other small pieces such as brackets and gas valves.

Demonstration scale biogas reactor in Mugonero

The reactor can operate solely on cow dung, or together with a mix of other organic matter, such as pig or chicken manure and kitchen leavings. The cow dung is mixed with water at a ratio of 1:1; or until the mixture has attained a paste-like consistency. For most efficient use, the reactor operates as a continuous flow system. After initial filling the plant is to be fed roughly 60 litres per day, or 120 litres twice a week. In Mugonero and Muramba KIST engineers instructed the plant caretakers to burn the biogas to completion everyday, and then to refill the reactor.

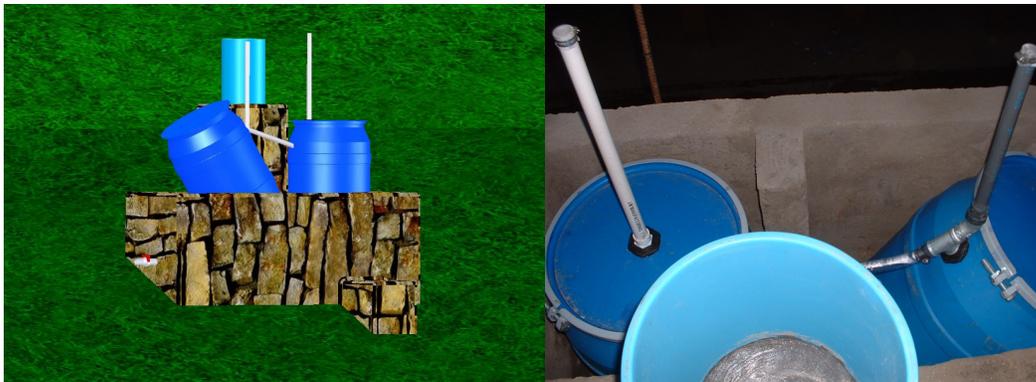
A noteworthy feature of the upper housing is that it allows for complete disassembly of the treatment system; none of the system components are permanently fixed to the housing. This feature simplifies maintenance of the system. There is a small staircase built into the upper housing which permits smaller users to access the input bucket.

Figure 7-4 (left): Cad drawing of the upper masonry housing. The vertical tubes in both pictures are the backwash tank vacuum relief and the settler siphon break respectively.

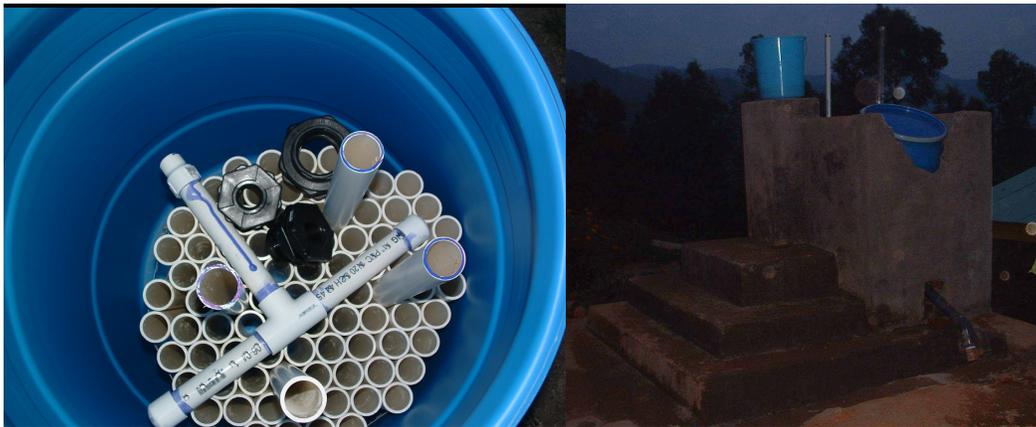
The tube settler is the first treatment step in the system. The water flows upward through a set of 1” tubes that are inclined 60° from the horizontal. As the water travels through the tubes, sediment settles downward vertically through the inclined columns of water. The array of tubes serves to minimize the distance a given piece of sediment has to travel before reaching a surface. Once a particle contacts a surface, it will adhere to other particles on the surface and form a small floc (clump). These accumulations eventually become heavy enough to slide downward through tubes and settle at the bottom of the tank. Without the tube array, the average settling particle would have to travel a distance greater than the radius of the drum before contacting the side and the settler would be less effective. Conversely, with the array in place, the average particle only has to travel a distance equal the diameter of a single tube. The water enters the settler from the lower portion of the drum via a “T” shaped distribution arm that is connected to the input bucket via the input bulkhead. The distribution “T” is perforated with ¼” holes at 1” intervals. These holes are directed upward to prevent the incoming water from disturbing the sediment that accumulates in the bottom of the drum. The tube bank is suspended above the distribution “T” by a set of four legs that position the tube bank in the center of the drum.

Figure 7-6 (left): The parts of the tube settler in a disassembled state. The tube bank is the upside down relative to its intended position in the drum. The four tubes that extend above the bank are the support legs that keep the tube bank elevated within the drum. The distribution “T” is clearly visible in the center of the picture. The annular black objects are the bulkheads that are used to make water tight fittings through the drum walls.

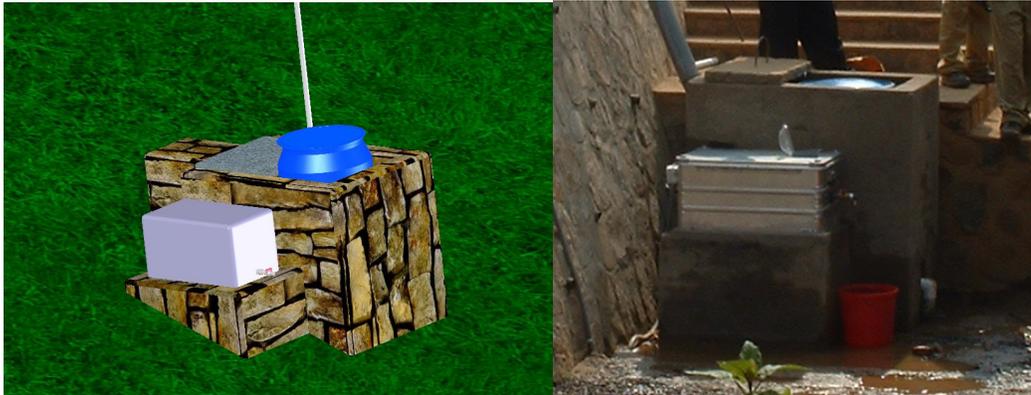
Figures 7-9, 7-10: CAD model and photograph of the lower housing. The silver container is the UV disinfection box resting on its pedestal. The sand filter is the blue drum enclosed in the masonry. The valve box is located behind the filter drum.

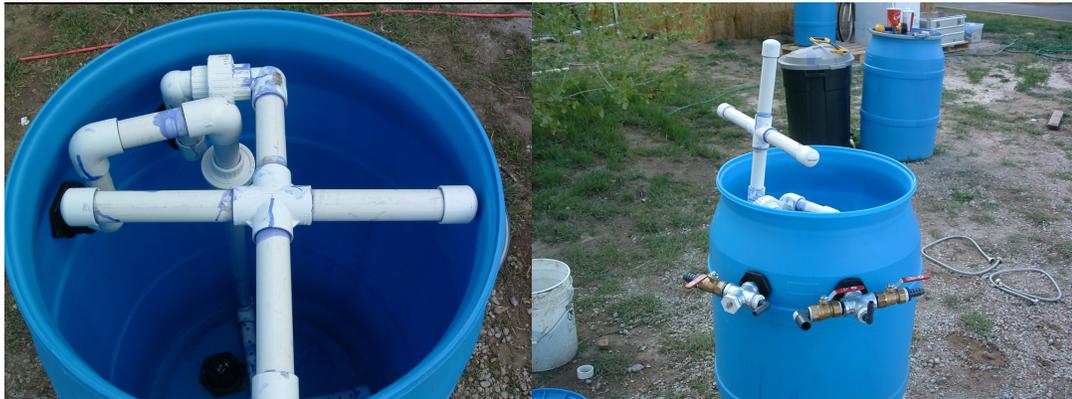
Unfiltered water enters the top of the filter through the distribution arm and is broadcast across the top of the media bed. It is constructed of 1" PVC pipe in the shape of a cross. The arms of the cross are perforated with ¼" holes spaced at 1" intervals along the bottoms of each of the arms. Three of the four arms of the cross are terminated with PVC plugs while the fourth arm is connected through a bulkhead in the PDSF wall to the valve box. The line from the distribution arm to the bulkhead features a PVC union that allows the distribution arm to swing upward and out of the way to facilitate access to the media. This line is plumbed to position the distribution arm as high as possible in the filter body without obstructing closure of the drum lid.

Figure 7-12 (left): Top view of the PDSF. Both the distribution arm and the filter output pipe are visible in this view.

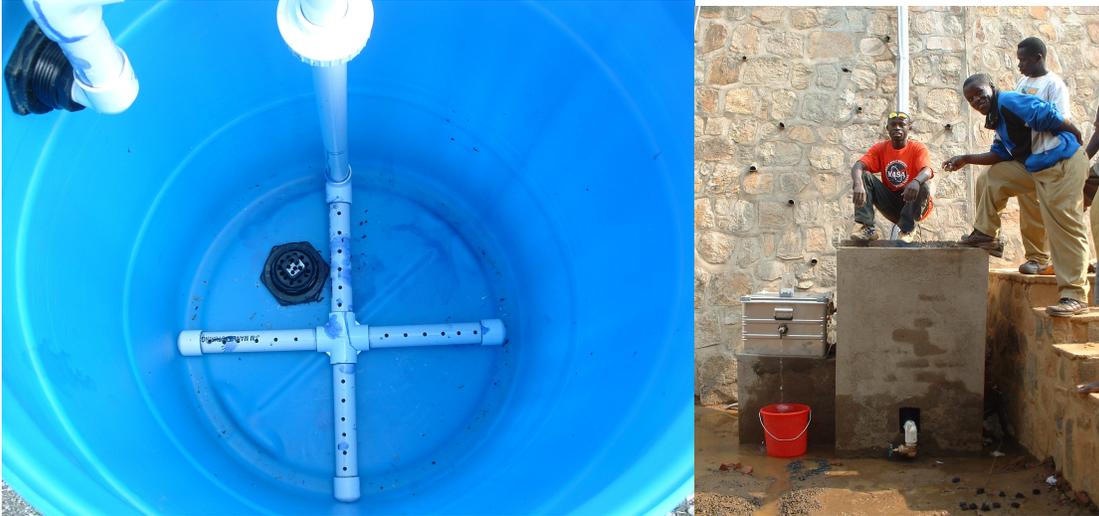
The maintenance drain allows the filter body to be completely emptied of water if the need arises. Like the sediment drain on the settling tank, this drain features a gate valve in a vertical orientation to reduce the possibility of particulates interfering with the operation of the valve. The outlet for the maintenance drain features a perforated plug to prevent the loss of media through the maintenance drain. The maintenance drain can be detached from the filter drum if there is a need to remove the filter drum from the lower housing.

Figure 7-14 (left): A view of the underdrain and the outlet for the maintenance drain (black). Also visible in this figure is the union on the filter output pipe that allows the underdrain assembly to be removed.

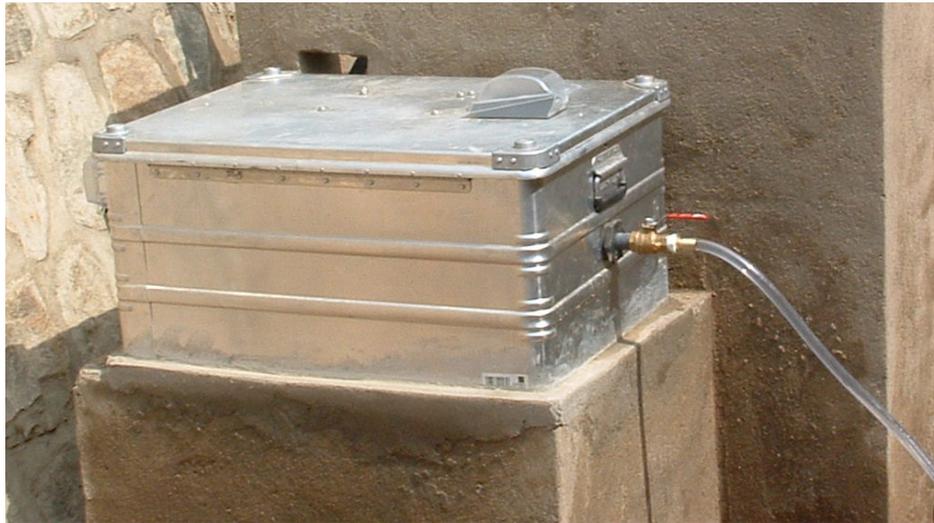
Figure 7-15: UV system box

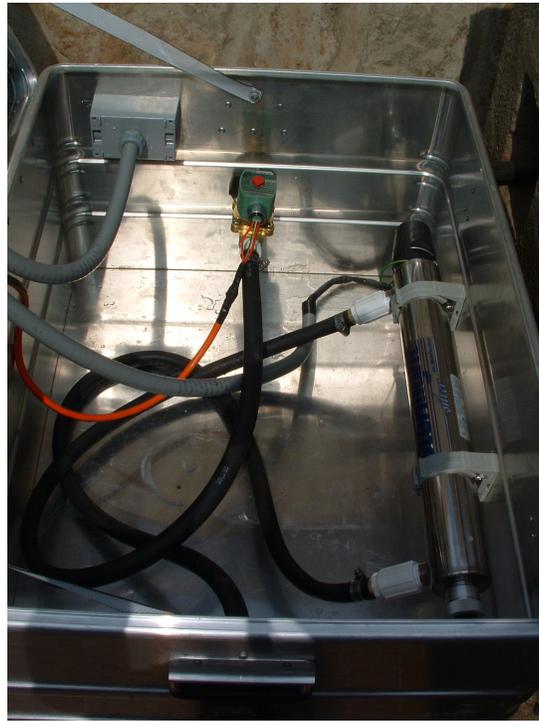
Figure 7-17 shows the internal plumbing and electrical connections of the UV box. The green valve visible at the top of the picture is a standard Asco solenoid valve. The purpose of the valve is to allow a one-stop operation of the system. Turning on the electric timer switch simultaneously allows water flow and turns on the UV light. However, should the valve fail, it can be easily removed and water flow provided by a standard hand valve visible in Figure 7-17.

Figure 7-17: Inside of UV system box

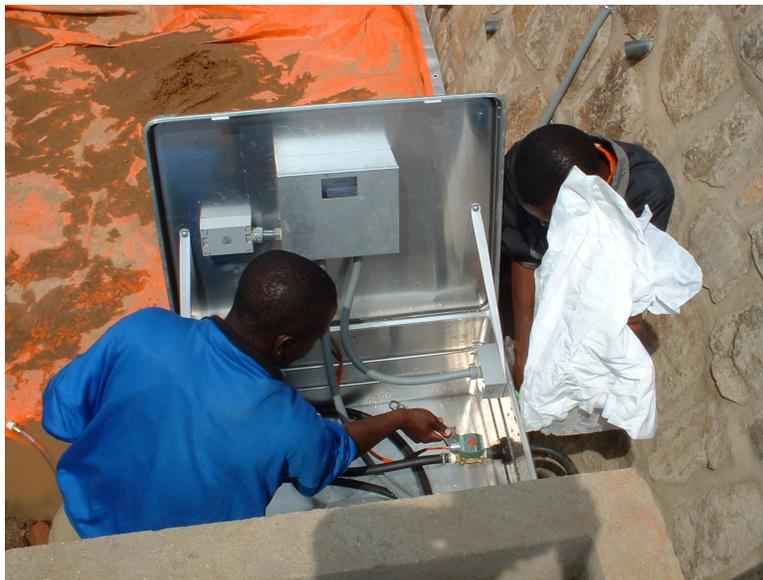
Figure 7-18 shows the inside of the box including the weatherproof UV ballast box, shown bolted to the top of the aluminum enclosure box. This ballast regulates the power to the UV unit, and times the total operating time of the UV unit. Should the UV bulb fail or wear out, the ballast will alert users and maintenance personnel with a sustained beeping sound. The box is locked so that only trained personnel may access the UV unit, to minimize the chances of someone being exposed to dangerous UV radiation.

Figure 7-18: Inside of box showing UV ballast control

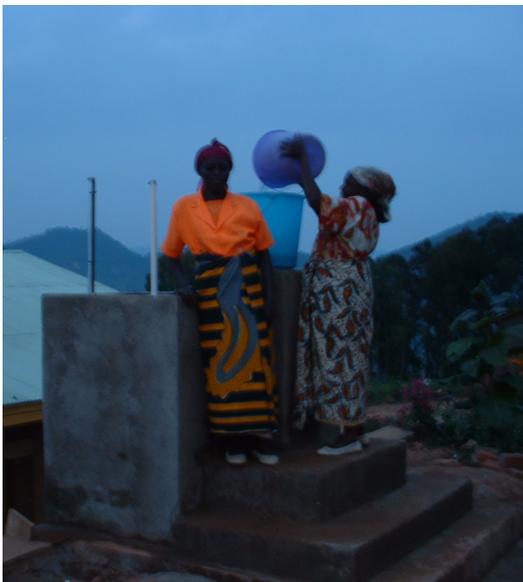
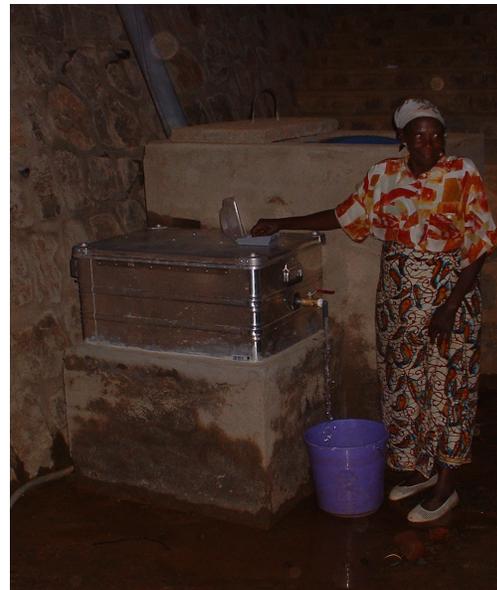
Water treatment with the BYOW system begins when a user pours a container's worth of water into the input bucket on the upper portion of the system. The act of adding water to input bucket effectively "charges" system, providing the hydraulic energy needed to drive the water through the treatment processes. The user then carries their empty container down to the output side of the system at the bottom of the wall. The user places their bucket under the output faucet and activates the electronic timer switch. This switch simultaneously activates the UV disinfection unit and opens the electric solenoid valve, allowing the water to proceed through the treatment system into the user's container. The water will continue flow until the user receives a quantity of treated water equal to that which they poured into the system (or slightly less depending on system configuration), a process which takes about two minutes for a typical 20 liter jerry can of water.

Figures 7-19, 7-20: A local woman pours her water into the system input bucket for treatment and then collects it at the system output by operating the electric valve switch.

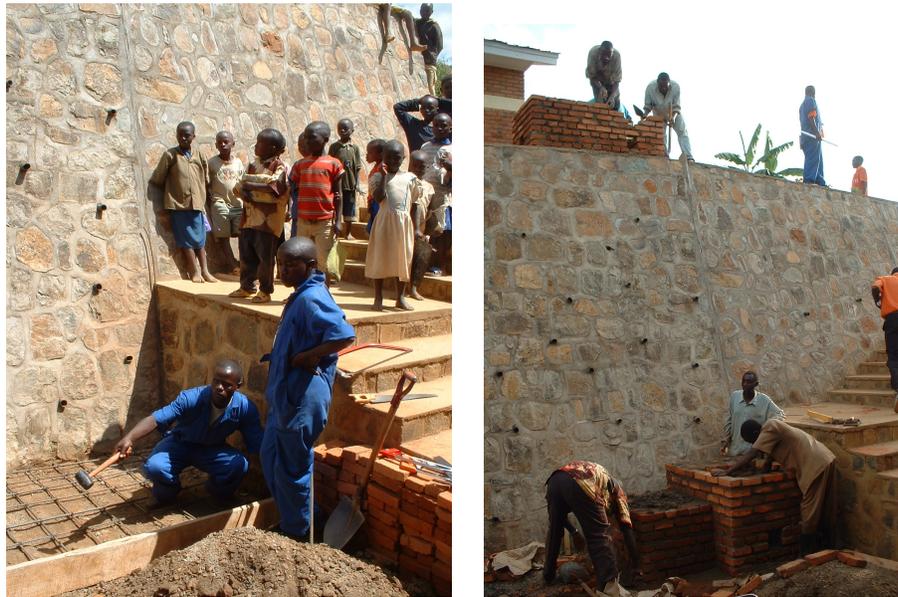
The first step in installing the BYOW system was to excavate 3” of soil and level the ground where the foundations were to be poured. 4” reinforced concrete slabs were poured at the upper and lower construction sites.

Figure 7-21: Foundation and housing construction

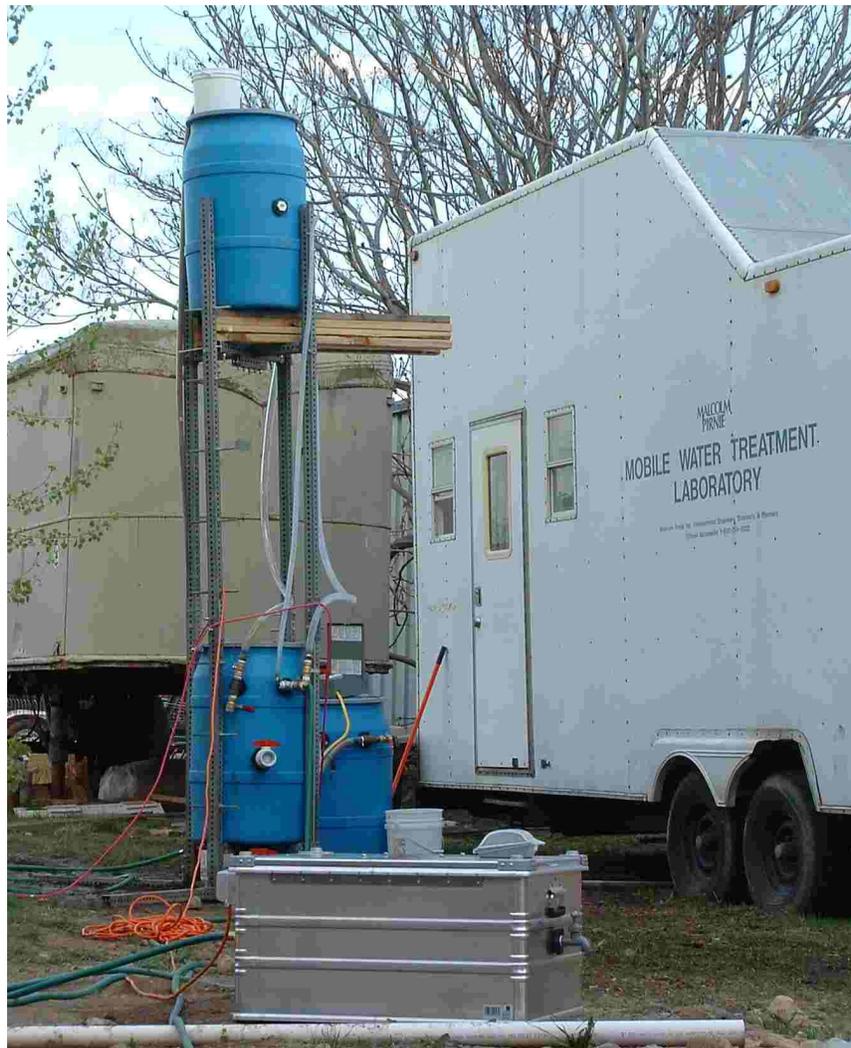
A water quality pilot study was conducted on the prototype system prior to the implementation in Muramba. These tests were conducted at the EWB-CU Appropriate Technology Field Laboratory at the University of Colorado at Boulder. The test apparatus utilized an adjustable metal tower constructed from recycled sign posts to create the necessary elevation differential. This tower suspended the upper portion of the system above the PDSF and the UV reactor. The system was fed tap water mixed with silt and horse manure to simulate the bacteria laden, turbid water found in Muramba. The raw water was pumped through the system on an intermittent basis for a period of two weeks to allow the system to stabilize. This intermittent flow was facilitated by the use of an electric valve connected to a timer. Three sets of tests were conducted, taking water samples at the inlet, after the sand filter and after the UV reactor.

Figure 7-29: BYOW prototype at the EWB-CU Appropriate Technology Field Laboratory

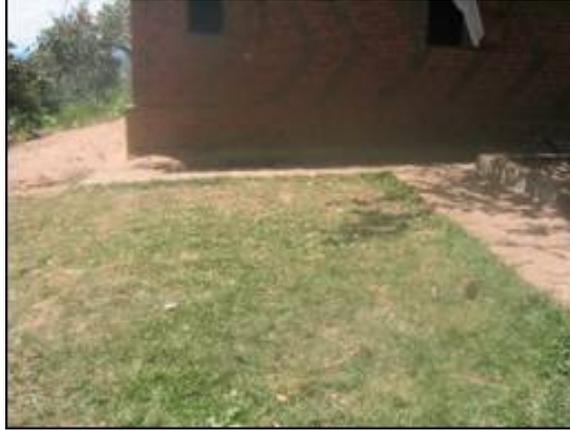
Figure 8-4: Tank Location for RWC System #1

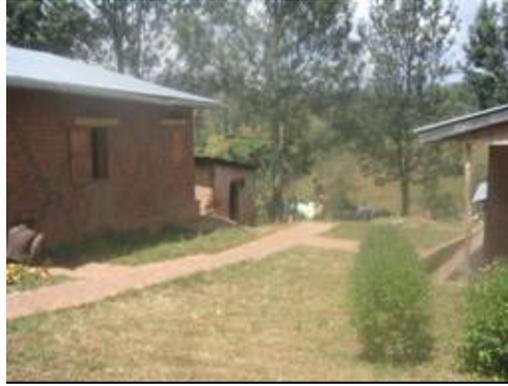
Figure 8-6: Tank Location for System #2

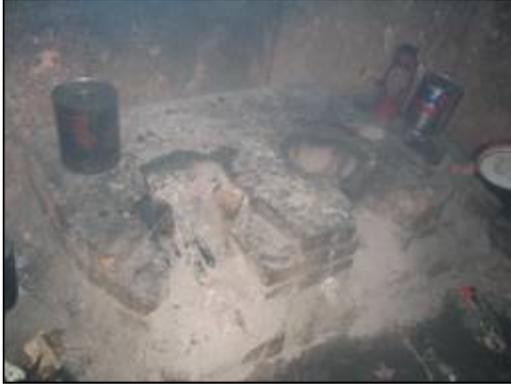
Figure 8-7: Typical Hearth at the Orphanage Figure 8-7: Typical Kitchen

Width	Length	Height
Building M11	3’	4’	6’
Building M11	3’	4’	6’
Building M13	3’	8’6”	2’
Building M16 (right)	2’3”	6’3”	1’8”
Building M16 (left)	3’5”	6’8”	2’
Building M18	3’5”	8’8”	2’
