Post-Assessment Report

Chapter: **South Houston Professional**

Community: **Maejanoi**

Project: **Water Containment and Quality**

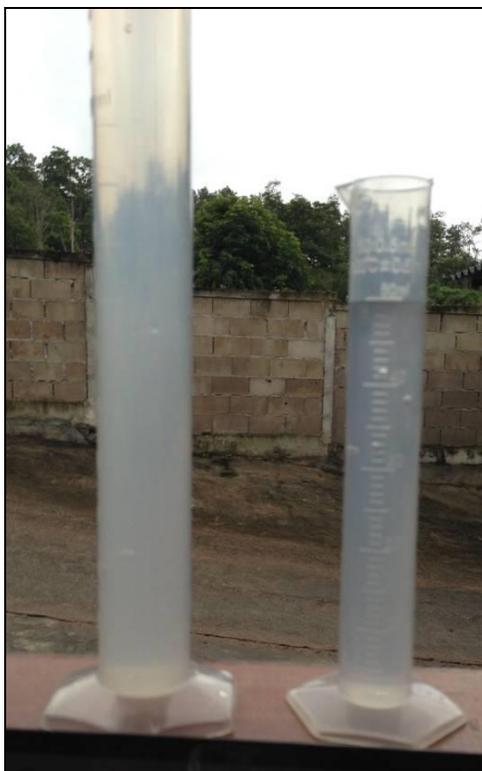
Turbidity was examined visually using a graduated cylinder. The goal was to create a quantitative measurement index by recording how full the cylinder could be before it was not possible to see the bottom of the cylinder. However, all samples were clear enough that the bottom of the cylinder was always visible. Water near the source was very clear while water from faucets in the homes was slightly cloudy. Figure 6 shows a comparison of bottled drinking

water on the right to cloudier water from Be's faucet on the left to illustrate the turbidity. Samples returned to Houston may have turbidity measured quantitatively using a turbidity meter.

Figure 6: Cloudy water from kitchen faucet (left) compared to bottled drinking water (right)

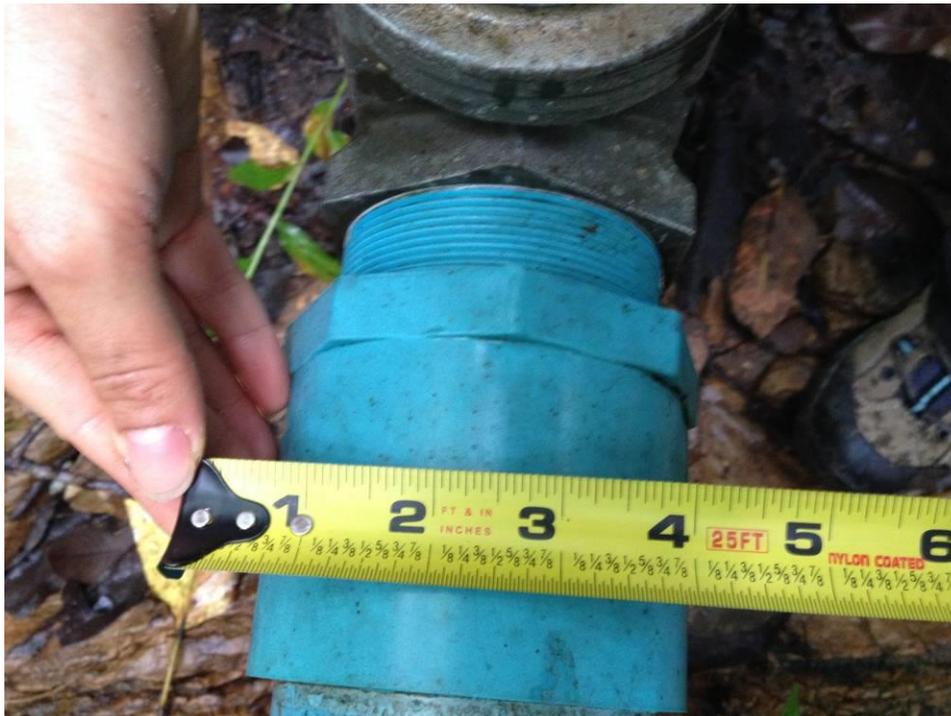
Dimensions of tanks and pipes in the current distribution were measured with a tape measure and documented with photographs. PVC piping near the source was on the order of 4 inches in diameter while piping in the village was roughly 1 inch. The tank near the source (labeled tank 1 in the maps) is approximately 49x38x89 inches, giving a volume of about 700 gallons. Each of the four primary village tanks (near the road in the maps) are cylindrical with a 112 inch height and 79 inch diameter. Therefore, each tank can hold approximately 2300 gallons. Each house has at least one water faucet.

Figure 7: Example photo documentation of water system dimensions

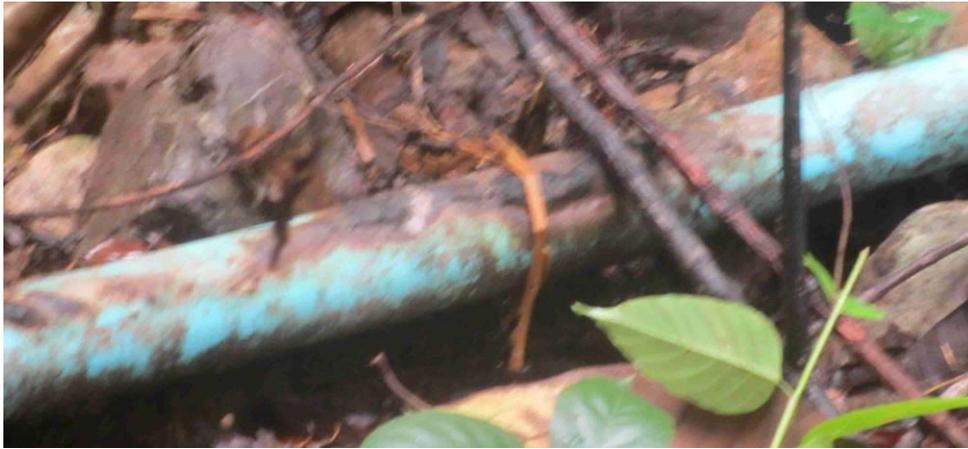
The primary water source is a stream located across the road and uphill from the village. This will be referred to as the village water source throughout the document. Water flows down to that level from further up the mountain. The PVC pipes start at this source, water flows from them into a rectangular cement tank near the source, then pipes continue toward 4 larger cylindrical cement storage tanks near the road. A valve is located a few meters downstream from the rectangular tank, it is used to shut off flow when pipes are being repaired. The rectangular tank has a cover, but there are openings in it. The pipe system goes under the road via an existing tunnel. Small (1 inch diameter) pipes branch off the main line going to each house – every house has at least one faucet. Most of the pipes on the hill side are above ground since it is too rocky to dig. Some pipes have been damaged by forest fires (which occur

Figure 13: Example of burnt pipe section damaged by forest fire

This distribution system has been in place for 3-4 years. The materials were originally donated by an outside group, and the system was built by the villagers. The storage tanks by the road were also donated. A maintenance fee of 10 baht/month is currently collected from each household to pay for repairs to the system – responsibility for maintenance rotates with 3 households every month. This existing PVC pipe distribution system is in good shape and is maintained. Consideration may be given to better protection against fires and falling trees (possibly using stone walls).

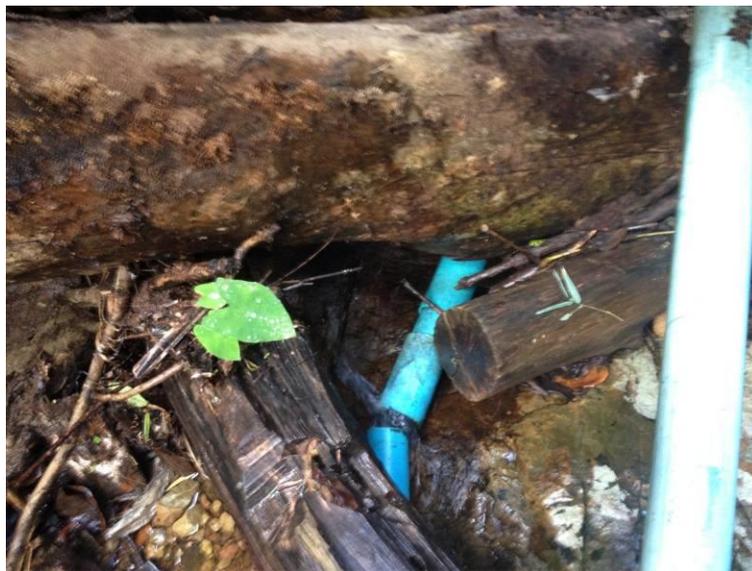
Figure 14: Example of broken pipe section after tree fall

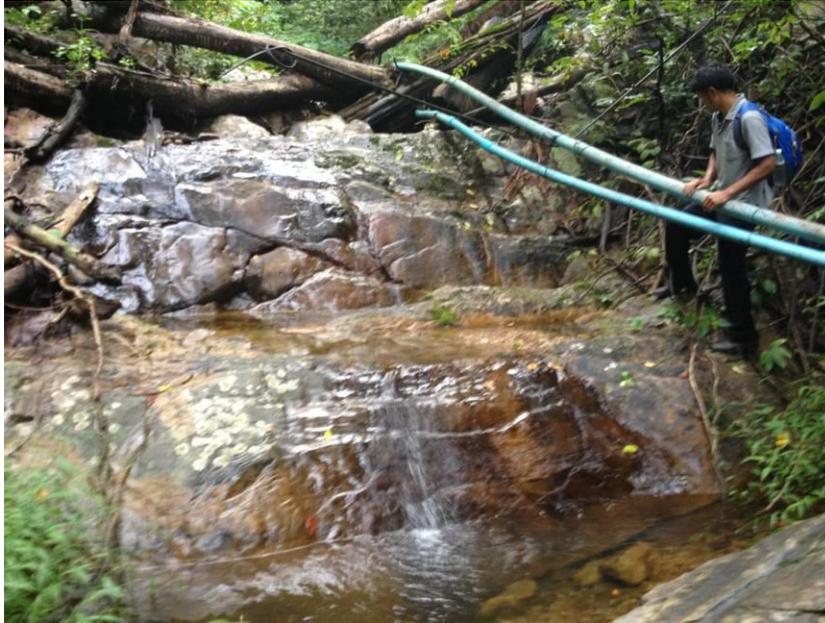
Figure 15: Water distribution system piping in the forest. Water is brought from the source to the 4 major storage tanks near the road. Pipes are above ground due to the rocky landscape.

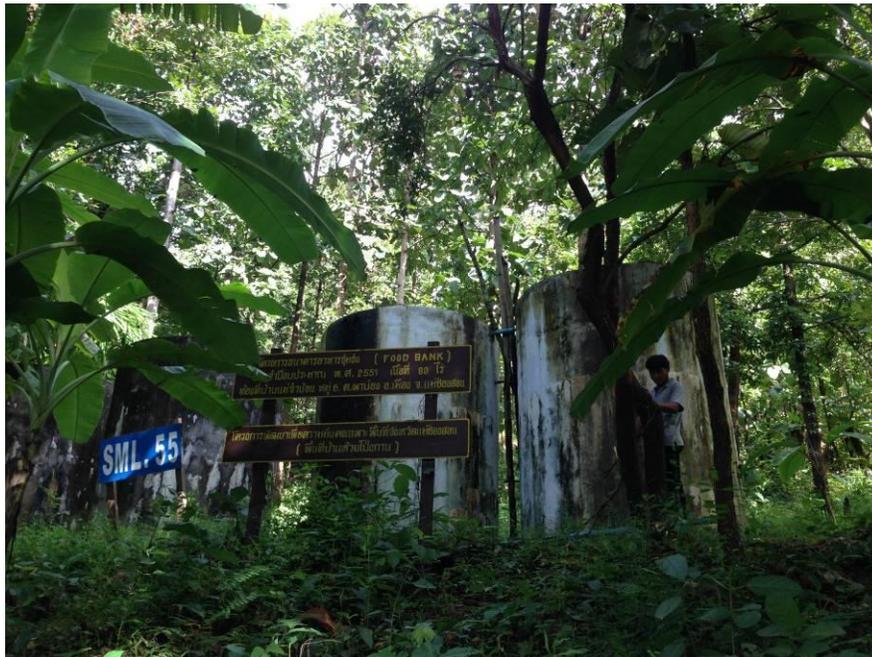
It rained during the first few days of the assessment trip, and the travel team saw that the storage tanks were overflowing with the excess water just flowing onto the ground. After a few days without rain, there was no overflow. There is currently no collection of rainwater – the villagers thought it would be good to do so, but cannot afford a collection system.

Figure 16: Four primary village tanks near the highway

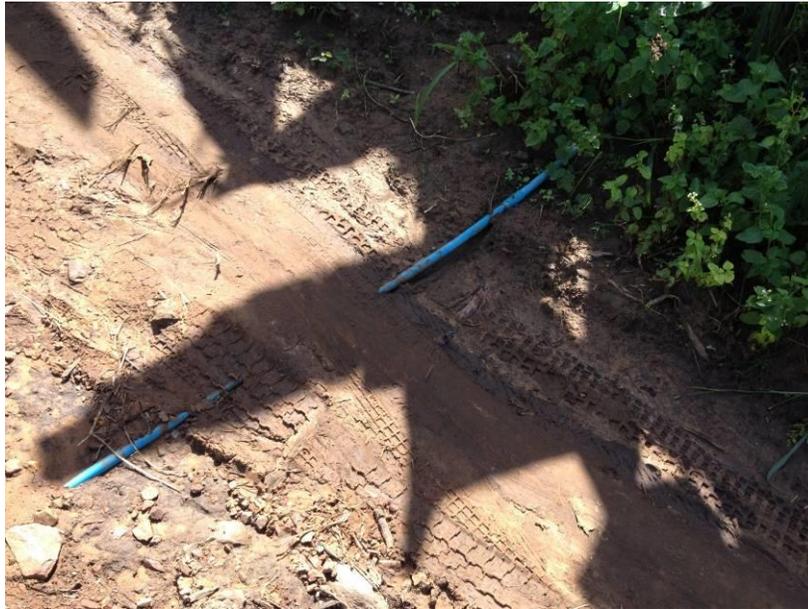
Figure 17: Water distribution system pipe in village. Pipes may be covered or above ground in the village due to mudslides.

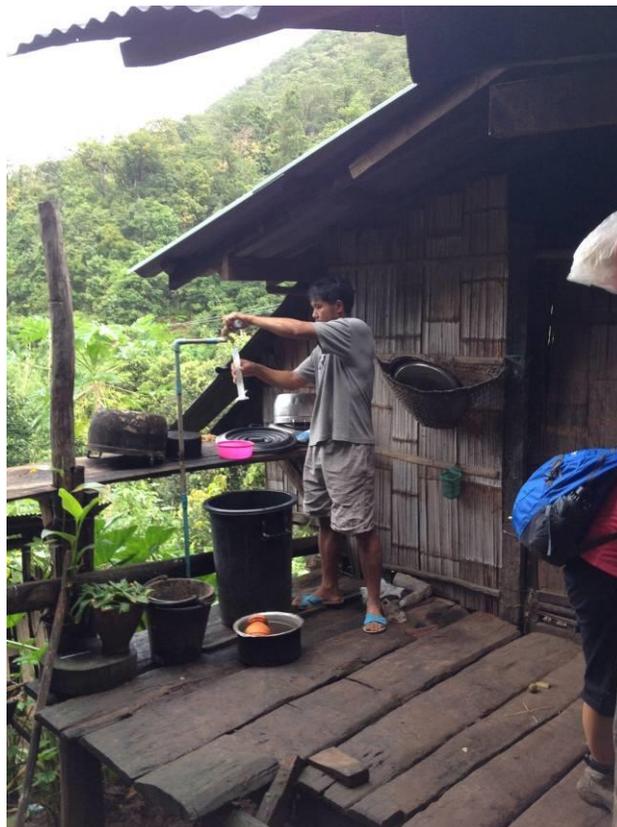
Figure 18: Water point of use for one household

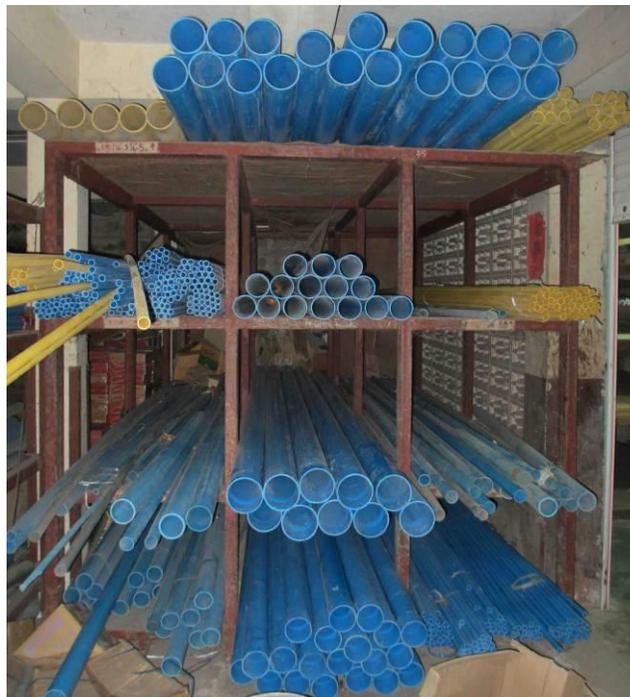
Figure 26: Example pipe selection at hardware store in Mae Hong Son
